Study on application of fiber-reinforced concrete in sluice gates

Yu Wen Liu^{a,*}, Shih Wei Cho^b

^a Department of Civil and Water Resources Engineering, National Chiayi University, Chiayi City, Taiwan, ROC

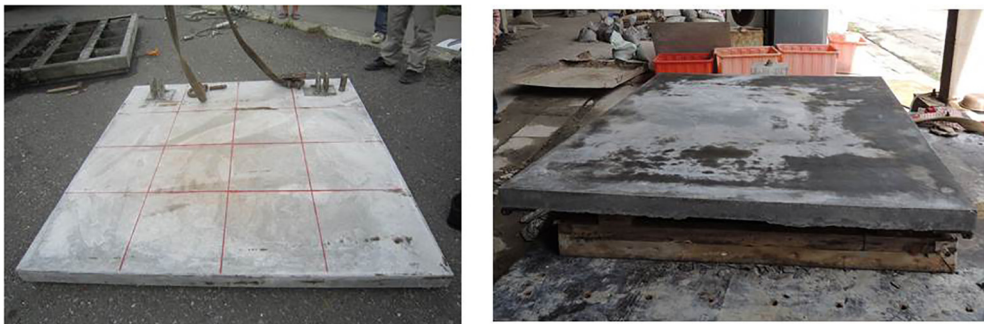
Fig. 7. Surface of the demolded FRC sluice gates.

embankments, set bolts were prepared around the sluice gates for the installation of rubber water seals to render the sluice gates watertight. In this study, P-type nonporous gate water seals were employed, as shown in Figs. 4–6. And Fig. 7 shows that both freshly constructed FRC sluice gates had a fairly smooth surface and contained few visible bubbles or pores.

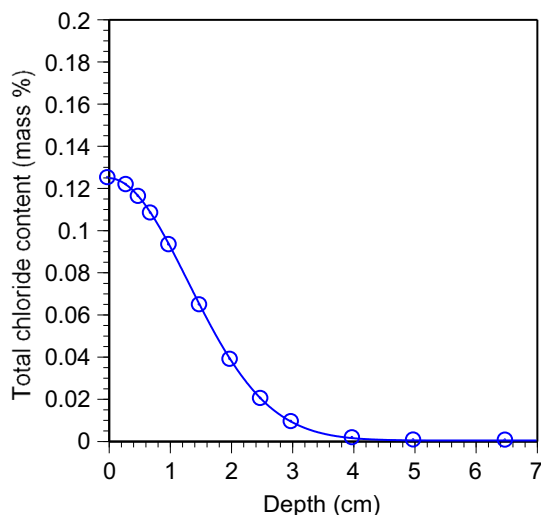
Fig. 8. Test result of ponding test of fiber-reinforced concrete.

The results of the durability test can be figured out with Fick's second law in Fig. 8 after a 90-day salt-ponding test (ASTM C1543). Which shown that the chloride diffusion coefficient of the concrete was $2.25 \times 10^{-12} \text{ m}^2 \text{ s}^{-1}$. According to Fick's second law of diffusion, when the atmospheric chloride concentration of a structure is lower than 0.05% and the chloride diffusion coefficient of concrete used in the structure is lower than $3 \times 10^{-12} \text{ m}^2 \text{ s}^{-1}$, it will take approximately 50 years for chloride ions to reach the surface of rebars via concrete pores. After it was alternately exposed five times to dry and wet impregnations using sodium sulfate, the concrete had lost 1% of its weight and had a compressive strength loss of 0.9. Accordingly, the concrete used in this study met the service life requirements of typical structures, had low weight and compressive-strength losses before and after robustness testing, and therefore exhibited high resistance to sulfate erosion.

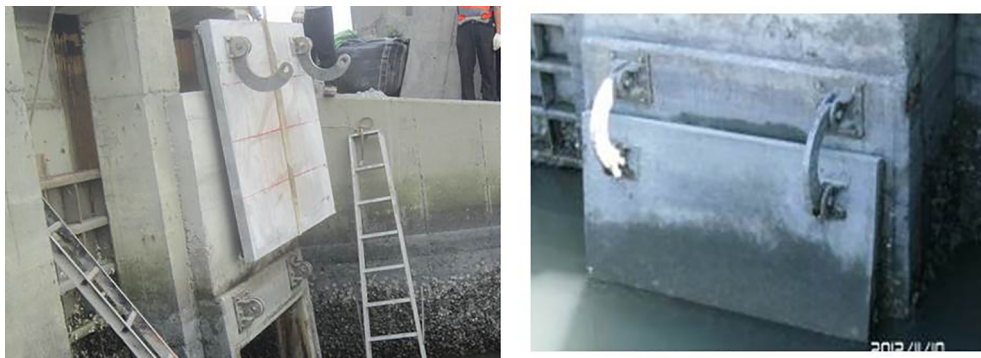
Fig. 11. Installation of Houanliao sluice gate.

occurred. Figs. 11 and 12 show the installation process and the completion of the process, respectively.

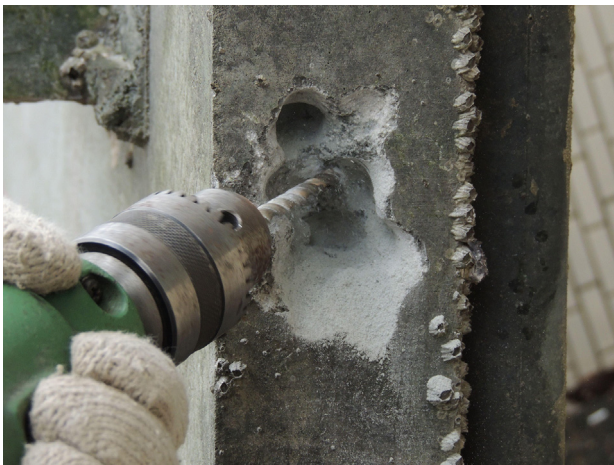
Fig. 16. Drilling one edge of sluice gate to assess the corrosion of rebars and wire meshes.

One edge of both FRC sluice gates was drilled so that the corrosion of their rebars and wire meshes could be assessed (Fig. 16).
