## Case study

## Failure analysis of a leaked oil pipeline

En-Na Yang<sup>\*</sup>, Chang-Ming Fu, Chen Dong, Shen Qu<sup>\*</sup>, Ji-Feng Tian,  
Zhe-Feng Zhang

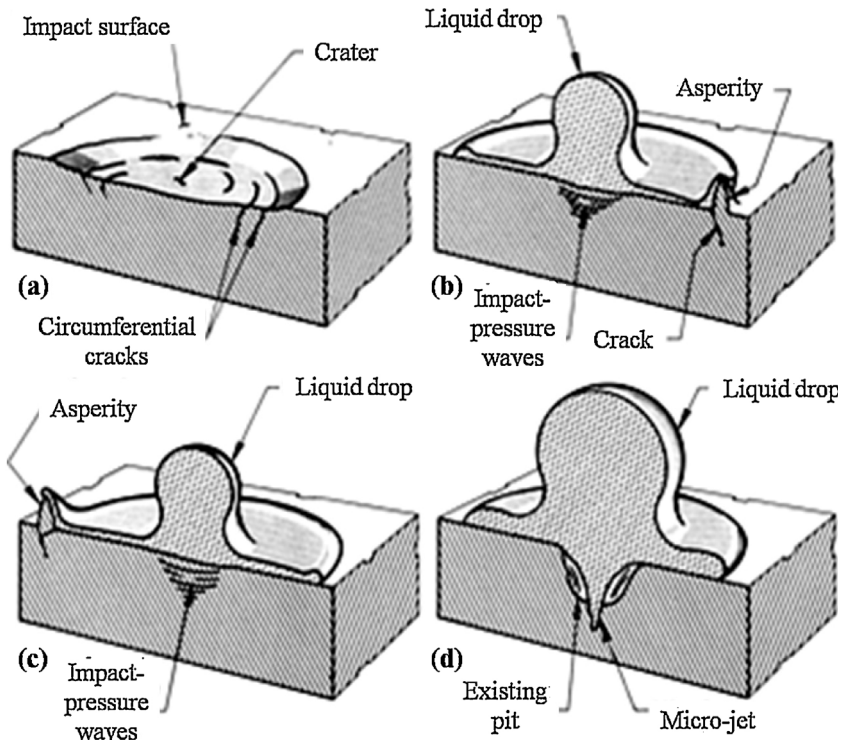
Fig. 7. Processes of materials' damage by liquid impingement erosion [17]: (a) solid surface showing the initial impact of a liquid drop that produces circumferential cracks or shallow craters; (b) high-velocity radial flow of liquid is arrested by a nearby surface asperity, at the base of which cracks are initiated; (c) subsequent impact by another liquid drop breaks the asperity; (d) direct hit on a deep pit results in accelerated damage.

In order to further examine our predictions, the mechanism of liquid impingement erosion is discussed. In the handbook of *Failure Analysis and Prevention* [17] published by American Society for Metals (ASM), a model for the liquid impingement erosion was proposed, as illustrated in Fig. 7. According to this model, the erosion should be caused by continued impingement of liquid droplets. During the impact of liquid on the sample surface, the impact-pressure induced by the moving liquid can produce some circumferential cracks, or shallow craters or both, depending on the ductility of the material (Fig. 7a). Apparently, the craters are prone to form in the very ductile materials, while the circumferential cracks are expected to be preferentially observed in brittle materials but can also be found in ductile materials after repeated impact and plastic deformation. Following the impact, the liquid flows away rapidly along the radial direction. The flow of liquid would be blocked by some surface asperities or steps that may be formed by plastic deformation during the impact. Consequently, a crack is easy to produce at the base of surface asperities or surface steps (Fig. 7b and c). In the present investigation, key evidences supporting this model were found. First of all, the morphologies of the damage and the leakage of pipes are all pits and/or the aggregation of pits, which provides evidences for erosion. What's more, the different size of the pits as well as the large pit containing small pits demonstrates that the pits were formed by a number of repeated impacts, in good accordance with the continued impingement of liquid droplets in the model. Besides, convex ridges, which correspond to the surface asperities or steps, were found inside the pit (Fig. 3b). Moreover, a circumferential crack was also observed inside the large pit (Fig. 3d), consistent with the impact induced cracking at the exterior surface. Finally, the material of the pipeline is low-carbon steel that has a good plastic deformability, which makes the formation of tiny pits very easy and also well explains the uneven feature of the internal surface of the large pit. Consequently, the liquid impingement erosion can be confirmed to be responsible for the leakage of the pipeline.
