Paper No: 05-IAGT-2.1

MEASURES EMPLOYED AT UNION GAS TO ADDRESS HIGH CYCLE FATIGUE IN THE AVON HP TURBINE

Rick Wintjes

**Union Gas Ltd
A Division of Duke Energy Gas Transmission
Chatham, Ontario**

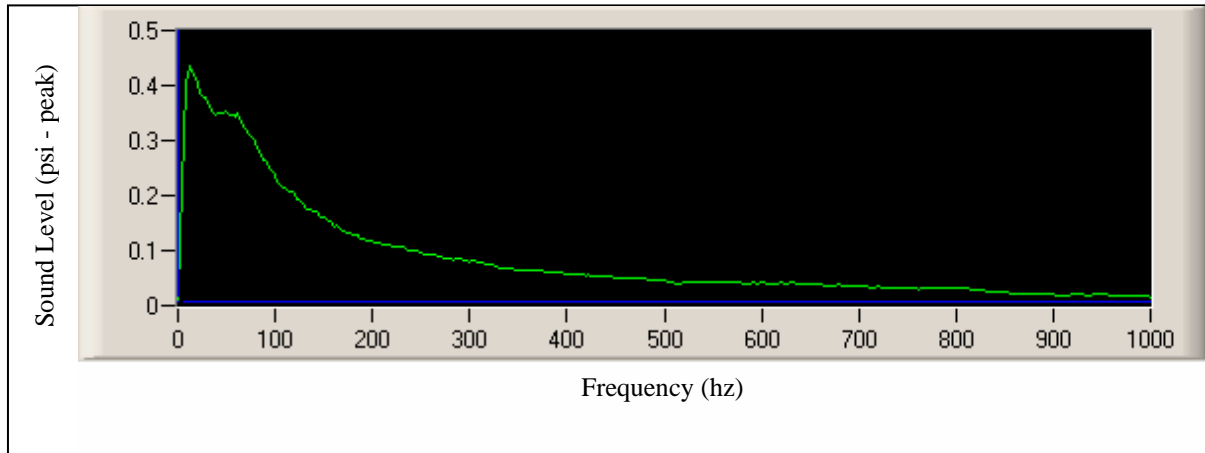
Figure 20 – Bright A2 (Engine 37842): December 20th, 2004.

Typical CP103 measurements for the 1533 engine show that low frequency noise levels are much higher than found at any of the 1534 or 1535 engines being monitored. Factors unique to the 1533 engine shown above include: the use of single dish combustors and the use of pintle style burner nozzles. There is insufficient comparative data to establish a definitive link between combustor configuration and the low frequency noise characteristics of the 1533 engine.

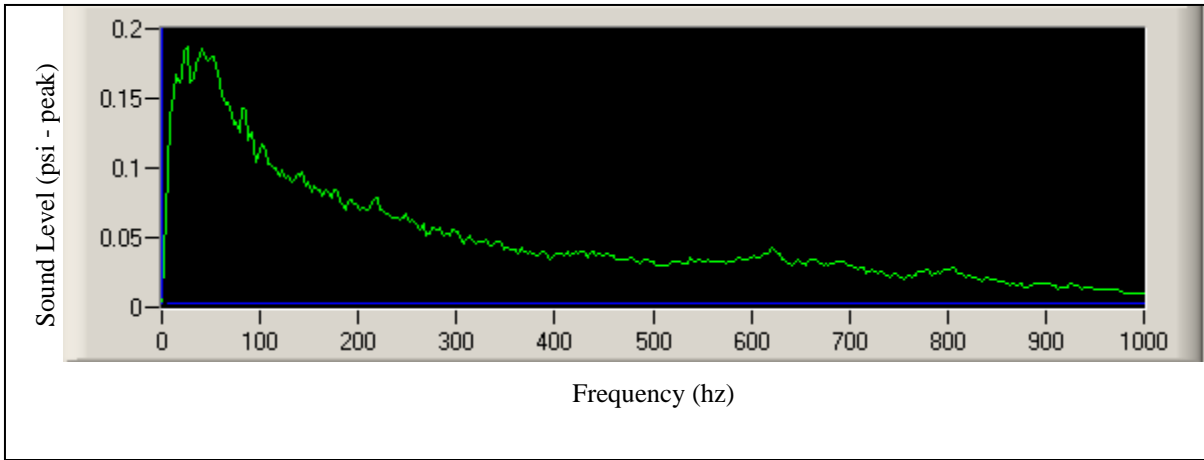
Figure 21 – Parkway (Engine 37813): October 28th, 2004.

CP103 data obtained from a like engine (1533 AVON - Engine 37813 – see Figure 21) shows a similar tendency towards high noise levels at low frequencies and very similar frequency distribution. Unfortunately, engine 37813 has been fitted triple dish flame tubes, so a direct comparison to engine 37842 would be inconclusive.

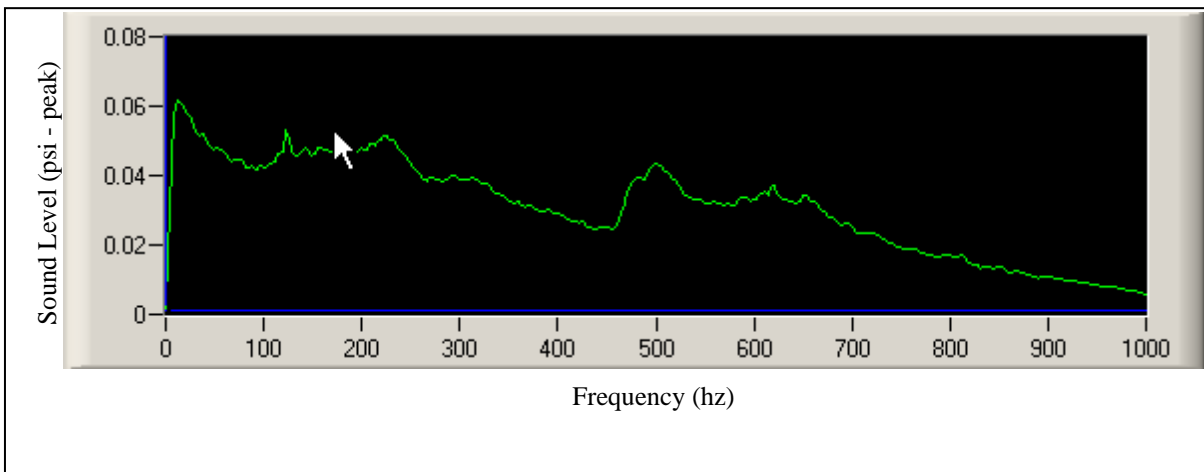
Figure 22 – Bright A1 (Engine 37433): June 27th, 2005

Normal frequency spectra for the 1534 engine (pintle burners and triple dish flame tubes) are believed to be as shown above. The spectrum above was produced using the CP103 signal obtained immediately after repair

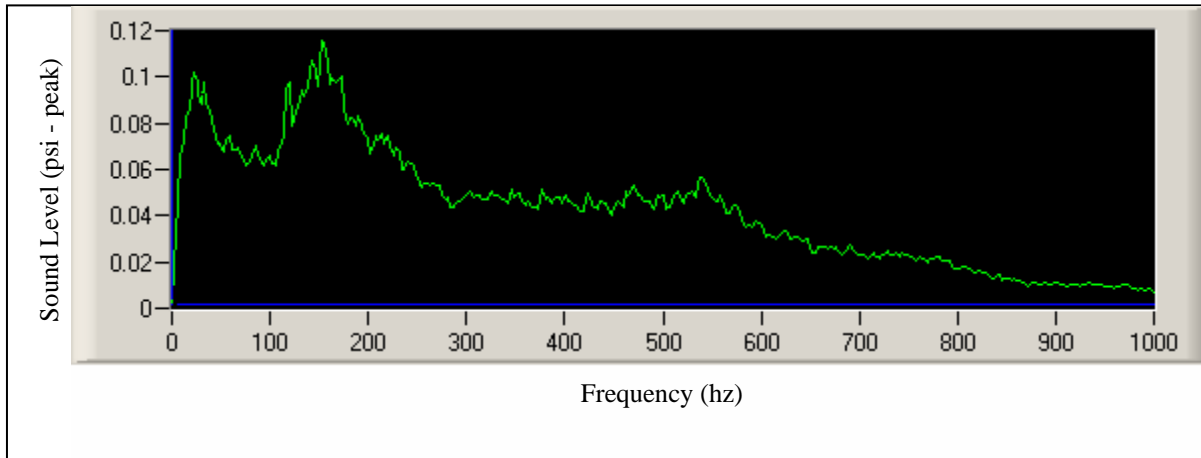
Figure 25 – Lobo A2 (Engine Lease): March 11th, 2004

Baseline CP103 data was collected from a leased 1535-161 engine (c/w triple dish combustors) at the end of the 2003/2004 operating season. Results are provided for reference purposes only.

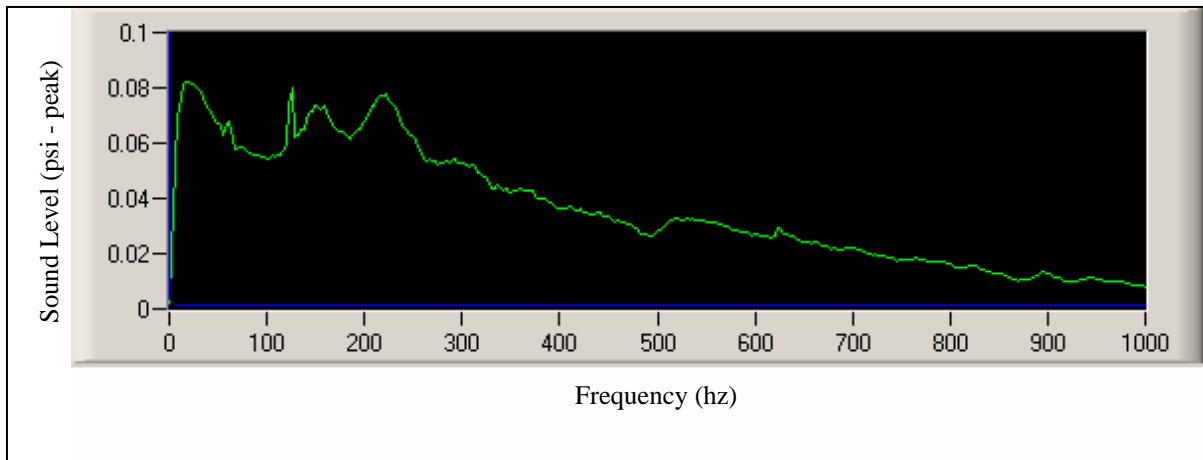
Figure 27 – Lobo A2 (Engine 38148): March 9th, 2005

Both AVON engines at Lobo are now 1535-161G engine configurations c/w swirler burners – see Figure 26 and Figure 27 for respective CP103 spectra. Installation of two identical engine configurations provides some insight into the consistency of the CP103 signal among like engines, in a similar maintenance condition.

Both Lobo engines exhibit well correlated frequency spectra (see Figure 26 and Figure 27). Of interest is the double peak at 150 hz and at 225 hz. This bi-modal characteristic may be related to the separate frequencies being generated by the swirling air at the centre of each burner nozzle, and the swirling gas as it enters the combustor.
