## The fatigue of impellers and blades

Impellers and blades are the key components of turbomachines, and fatigue is the main failure mode of impellers and blades. The status and progress of fatigue research on impellers and blades were systematically introduced through reviewing fatigue failures, numerical simulations of fatigue, and fatigue tests of impellers and blades in several typical turbomachines. High cycle fatigue caused by vibration was the main failure mechanism, and fatigue cracks usually initiated from the location of stress concentration. The resonance caused by the aerodynamic load was the main cause of fatigue failure of impellers and blades in a steady operating condition. The coupling of the meshless method and the finite element method and the combined fatigue test of actual impellers and blades are the developmental direction and research focus of the future.

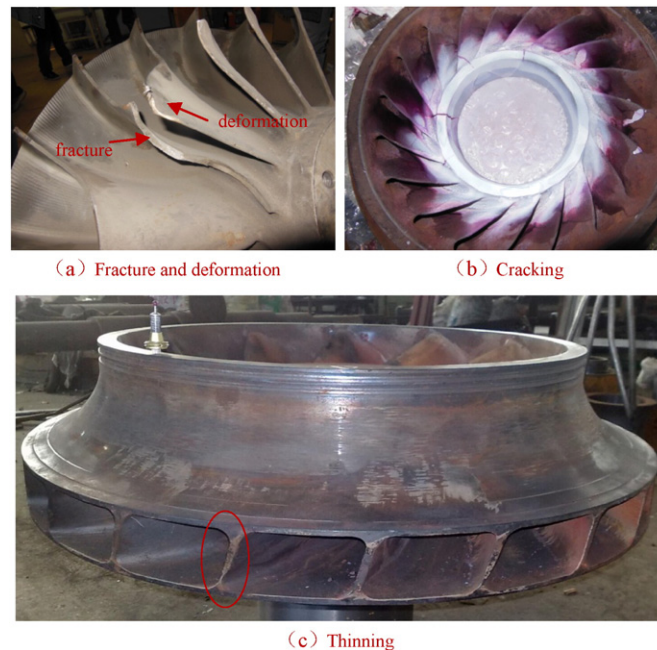
Fig. 1. The main failure modes of I&B.

The difference of “external reason”, such as the alternating load, corrosive medium, erosion medium, and high temperature, leads to the different failure mechanisms of I&B, which usually involve fatigue, corrosion, creep, wear, foreign object damage (FOD), and the combined action of these mechanisms [17–24]. The failure mechanisms are very different for different “external reasons” in various service environments [25–28]. The “internal reason” mainly affects the failure mode, especially the failure position. Fracture, cracking, thinning, and deformation are the main failure modes of I&B, as shown in Fig. 1. Cracking and fracture are more common, and can be caused by most of the above failure mechanisms. Thinning and deformation are relatively rare. Thinning usually appears in situations of serious wear or corrosion, for example, solid particles carried in the air increase blade thinning of centrifugal compressor impellers. Deformation can appear in the fabrication process, such as welding, but it appears

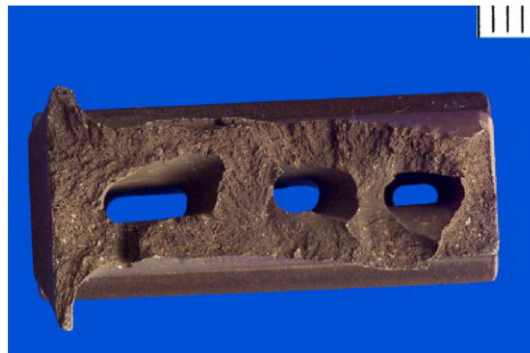
Fig. 14. Upper view of the fracture surface of the blade that was identified as the origin of the failure [90].

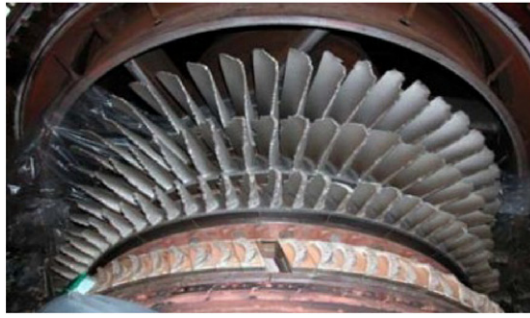
Fig. 19. Fracture of the first four stage blades [106].

Vibration is also the primary cause of fatigue of gas turbine blades. In 2010, Y. S. Choi [106] analyzed the failure of a gas turbine during the startup phase, and fractures of the first four stage blades are shown in Fig. 19. The fatigue fracture of a first stage turbine blade occurred at the blade root due to resonance. In 2012, Song [107] studied failures of two blades breaking off in a low pressure compressor of a gas turbine and some tenons cracking in the same stage. The failures were caused by vibration fatigue. The fretting of the bad assembly of disk and blade was the main cause of blade vibration fatigue.

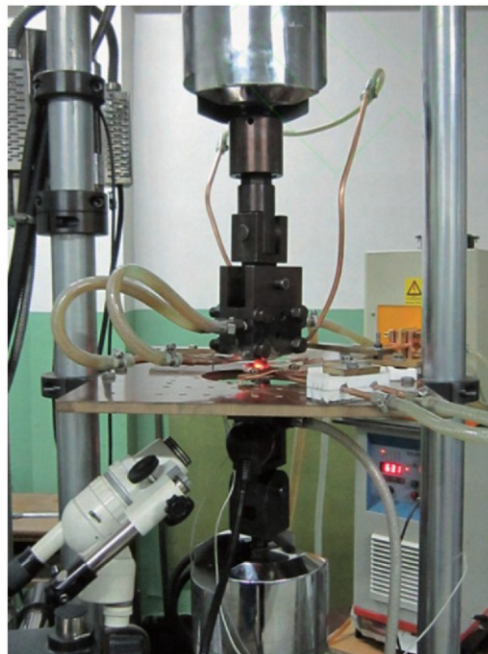
Fig. 20. Thermo-mechanical fatigue test system for blades [164].
