Assessment of the efficiency of prefabricated hybrid composite plates (HCPs) for retrofitting of damaged interior RC beam–column joints

Esmael Esmaeli^{a,*}, Joaquim A.O. Barros^a, Jose Sena-Cruz^a, Humberto Varum^b, José Melo^b

^aISISE, Dept. Civil Eng., University of Minho, Guimarães, Portugal

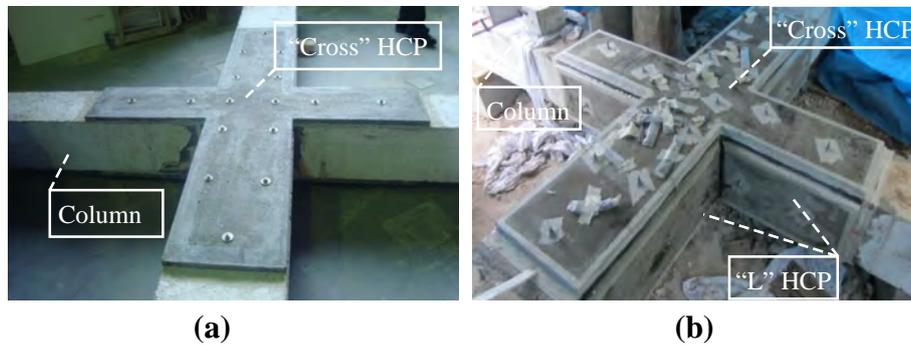
Fig. 6. View of the repaired specimens (a) JPA0-R and (b) JPC-R.

All the retrofitting process was performed with the specimens in horizontal position. For both specimens the remaining crushed and spalled off concrete at the corners of the joints was removed and then replaced with Sika Grout-213. To seal the cracks, boreholes were drilled through the cracked sections. After cleaning the holes using compressed air, small diameter pipes were placed inside them, then the superior face of the cracks was sealed and then epoxy resin SikaDur-52 was injected through these pipes. After turning the specimens, the sealing process was repeated to assure that the cracked section was sealed as much as possible. The concrete substrate was also slightly roughened using hand-held concrete scabber to partially expose the aggregates. This surface roughening aims to improve the HCP-concrete interface bond properties. Prior to the installation of the HCPs, chemical anchors were mounted inside the holes perforated on the beams, columns and joint regions, at the positions represented in Fig. 5. Before mounting the anchors, the holes were partially filled with Hilti Hit-HY 200-A as a fast curing injectable bonding agent. The embedded length of the anchors inside the concrete was 115 mm. Fig. 6 shows a view of the specimens after the HCPs have been applied.
