# EXPERIENCE WITH ON-LINE PARTIAL DISCHARGE MEASUREMENT IN HIGH VOLTAGE INVERTER FED MOTORS

**Abstract** – Partial discharge (PD) testing has long been an important tool for assessing the condition of the high voltage insulation in motor and generator stator windings. In the past several years, many motors have been powered from inverters which facilitate variable speed motor operation. The most common drive used today is the voltage-source, pulse-width-modulation (VS-PWM) type. VS-PWM drives rated up to 13.8 kV are becoming more common in natural gas processing plants, as well as in other petrochemical facilities. Such drives generate high voltage impulses in the kV range with risetimes in the sub-microsecond range. These impulses are a form of severe electrical interference that can make difficult the on-line detection of partial discharge (with magnitudes 1000 times smaller) due to the overlapping frequency content in PD and in the impulses. Thus, PD detection on medium voltage VS-PWM systems has been a challenge in spite of the serious stator winding insulation aging that such drives may cause to these motors. This paper discusses the stator winding failure mechanisms which pr

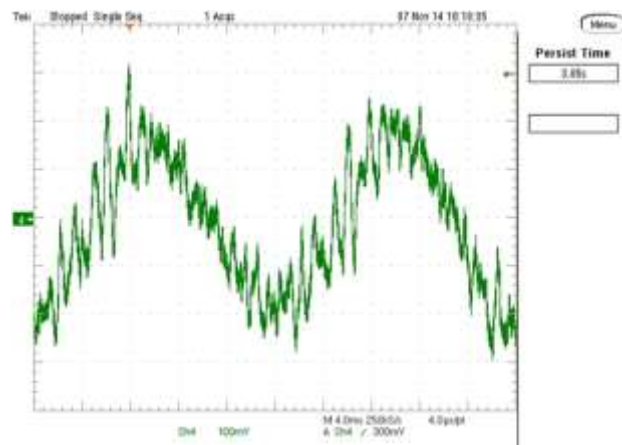
Fig. 2 Waveform of two ac voltage cycles measured at the motor terminals via a 20,000 to 1 voltage divider and filter. The fundamental frequency at the time of the measurement was about 20 Hz. The motor is rated 12.5 MW, 3 kV.

The introduction of medium voltage VS-PWM variable speed drives to the petrochemical industry has created a special challenge for on-line PD measurement. The switching impulse risetime in modern VS-PWM drives tends to be in the range of 500 – 1000 ns, with magnitudes of 1 - 2 kV (Fig. 2). This causes an additional type of “interference” with magnitudes that can be a thousand times higher than those of the PD pulses. The signal-to-noise ratio (-60 dB) is two orders of magnitude worse than that experienced by conventional 50/60 Hz motors in PD testing. This paper discusses the development of an on-line PD measurement system that is reasonably effective in suppressing the effect of switching impulses from the drive. The causes of deterioration in the stator winding, and especially in windings supplied by variable speed drives, are briefly presented.

Unlike conventional power frequency sources, VS-PWM drives produce large voltages at high frequencies. Fig. 2 shows the actual waveform of the voltage at the motor terminals on one phase, for a motor fed by a VS-PWM drive. As expected, there are many voltage transients on the waveform. The switching transients have a risetime of 500 to 1000 ns, and can reach 1500 – 2000 V in amplitude due to travelling wave reflections along the power cable between the motor and the drive. Thus, on the output of the capacitive PD sensors, the switching transients can result in impulses of many tens of volts, since the 1 MHz components of the transients are not suppressed as much by the high pass filter effect compared to 50/60 Hz frequencies. Fig. 4 shows the PD sensor output for a 12.5 MW motor. Many switching transients are observable on all three phases, even after the 40 MHz high pass filter. Phase 3 (3<sup>rd</sup> trace from the top in purple) indicates 15 V pulses (0 to peak) on the output of the PD sensor. This is about 30 times higher than significant PD activity. Clearly, these residual switching transients need to be strongly suppressed before on-line PD measurement can be made with confidence.

It is common in conventional on-line PD measurement to display PD activity with respect to the 50 or 60 Hz ac cycle. The pulse pattern gives greater assurance that the signals measured are PD (rather than noise), and can sometimes help in diagnosing the aging mechanisms. In most on-line PD measuring systems using capacitors as sensors, the ac voltage reference can be extracted from the PD sensor because a small amount of 50/60 Hz current does come through the capacitor. However, in the prototype installations involving VSDs, it was clear that a reliable fundamental frequency voltage could not be extracted from the PD sensor due to the switching transients (Fig. 2).

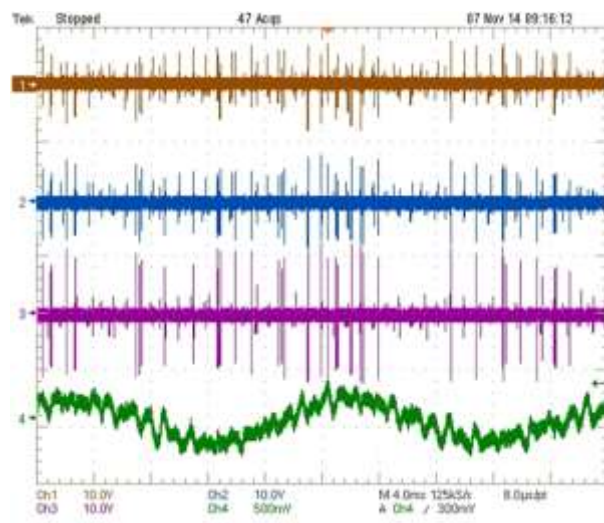
Fig. 4 Oscilloscope traces of the output of 80 pF PD sensors (top three traces, one per phase) vs. the ac fundamental voltage (bottom trace) in the 12.5 MW motor. Phase 3 is indicating 15 V pulses (0 to peak) on the output of the PD sensor.

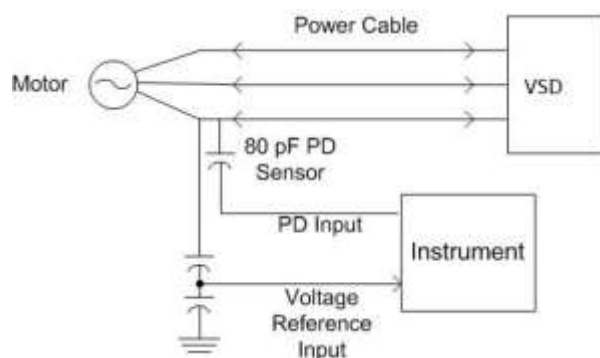
Fig. 5 Schematic of the PD monitoring system intended for drives.

Fig. 5 shows the schematic of the PD sensors plus capacitive voltage divider installed on a drive system.

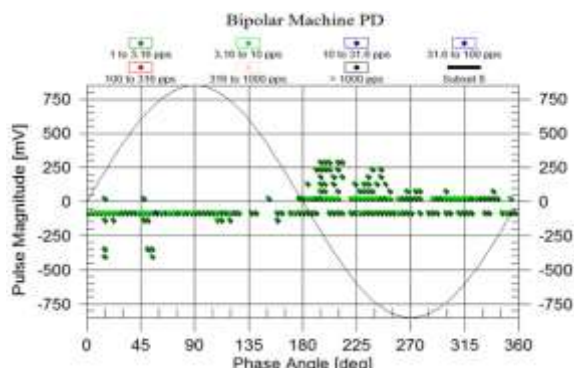
Fig. 7 PD pattern from one phase of a 45 MW, 7.2 kV motor fed by a VS-PWM drive. The vertical scale is the positive and negative PD magnitude. The horizontal scale is the ac phase position of the fundamental frequency voltage. The color of the dots indicates the number of PD pulses per second.

Data has been collected from many VS-PWM motors with the new PD measurement system. An example of the successful collection of stator winding PD data is shown in Fig. 7. This plot shows a classic PD pattern with respect to the ac cycle, that is, the positive PD occurs in the 180° to 270° quadrant of the ac cycle, and negative PD is occurring in the 0° to 90° quadrant of the ac cycle. In this case, the positive PD pulses are both higher and more numerous than the negative PD. Such a pattern is typical of PD at the stress relief coatings on the surface of coils operating at high voltage [14]. As described above, this problem is more likely with VS-PWM drive motors. The higher the PD, generally, the more aged the insulation [5], and thus the greater need for maintenance. In comparison to a PD database using 80 pF PD sensors

in conventional air-cooled machines, the peak PD magnitude measured on this machine is about 250 mV, which is well below the Alert level of 350 mV established for conventional motors rated at 6-9 kV [4].

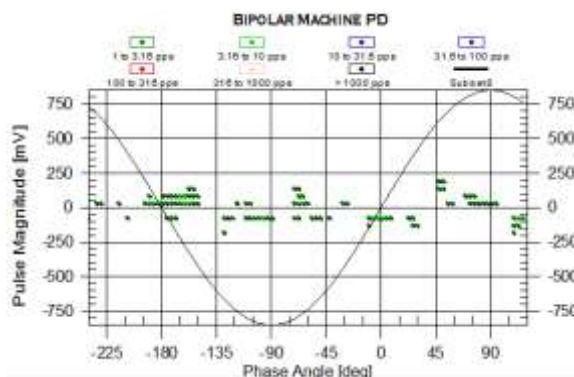
Fig. 8 PD pattern on one phase of a 12.5 MW, 3 kV motor. Very little PD is detected on this new winding.

Fig. 8 shows an example from a new motor that seems to have little PD activity. Both positive and negative pulses are scattered across the ac cycle, with a peak magnitude of 150 mV or so. The Alert level for a 3 kV motor is about 240 mV, so the stator winding of this motor seems to be well-made and is not yet suffering aging.
