Composite box girder with corrugated steel webs and trusses – A new type of bridge structure

Composite box girders with corrugated steel webs and trusses is a new type of advanced bridge structure proposed recently. This kind of structure consists of a top concrete slab, corrugated steel webs and two bottom concrete-filled steel tubes connected by trusses. The resistance to torsion and overturning of this kind of structure is larger than that of composite bridges with a single concrete-filled steel tube. This kind of structure is able to satisfy the requirement of rapid construction, environment protection and cost effectiveness. Two composite box girder bridges with corrugated steel webs and trusses have been or are being constructed in China. This paper presents the design of these two bridges in detail, which will provide valuable engineering experience for the further promotion of this kind of new bridge structure. Experimental research has been carried out to study the flexural behavior and the flexural capacity of this kind of new bridge structure. The test results show that when the test beam is at the elastic stage, the cross-section can be viewed as a plane section if onl

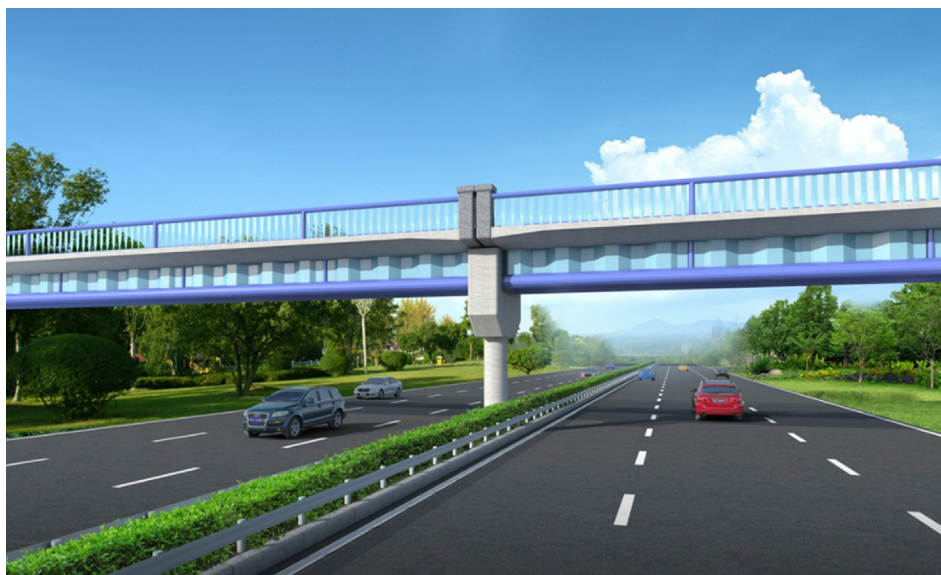
Fig. 3. A footbridge at Hebei Province, China.

The first composite box girder with CSWs and trusses that has been constructed is a footbridge located in Hebei Province, China, as shown in Fig. 3. It is a two-span simply supported girder bridge passing across the Beijing-Hong Kong-Macau Highway. This footbridge was designed by Shenzhen Municipal Design & Research Institute Co., Ltd.

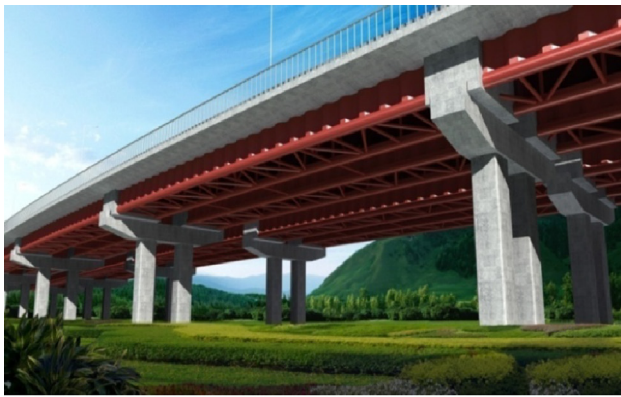
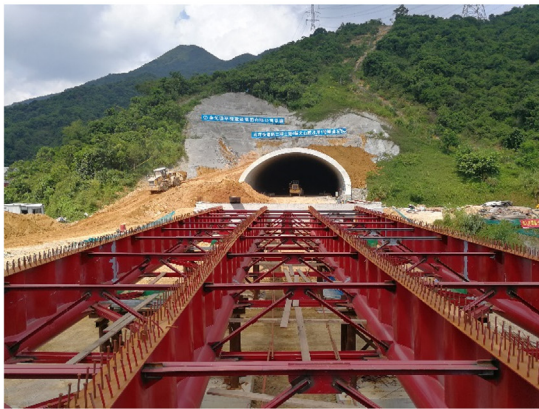
Fig. 5. Maluanshan Park Viaduct: (a) architectural rendering; (b) construction site.

Another bridge of this type that is being constructed is the Maluanshan Park Viaduct in Shenzhen, Guangdong Province, China. Several important factors were considered when designing the viaduct. First, it passes over a reservoir used for water supply, hence the influence of the bridge construction on the surrounding environment should be minimized. For example, the bridge should be constructed without the intensive use of temporary braces. Second, the bridge should also blend with the surrounding landscape. Finally, the bridge should be constructed rapidly, and the cost should not be too high. After careful consideration, it was decided to adopt the composite box girder with CSWs and trusses for this viaduct. The architectural rendering and the construction site of the viaduct are shown in Fig. 5. The viaduct is designed under the standard for an urban highway with a design speed of 80 km/h. The design of the Maluanshan Park Viaduct was also carried out by Shenzhen Municipal Design & Research Institute Co., Ltd.

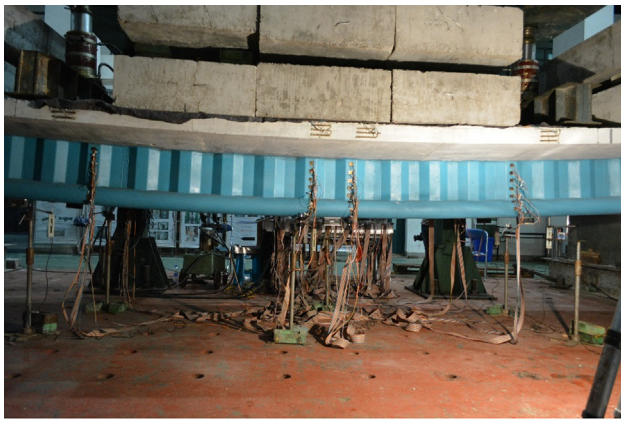
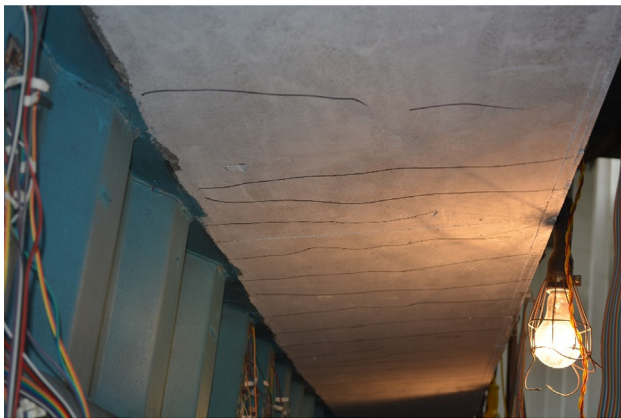
Fig. 11. Failure mode of the test beam: (a) overview; (b) observation at the bottom of the top concrete slab.

Fig. 11 shows the observed failure mode of the test beam. The deflection at the mid-span cross-section was 199.7 mm, which exceeds 1/50 of the span length of the test beam. Transverse cracks were observed at the bottom of the top concrete slab, as shown in Fig. 11(b). The materials in the test beam had reached their yield strength before it failed. Neither local buckling of corrugated steel webs nor local failures of structural elements have been observed.

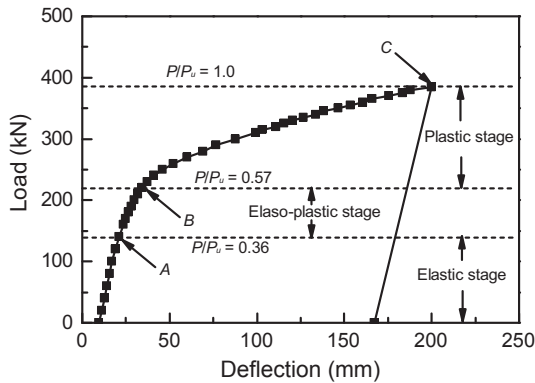
Fig. 12. Load-deflection curve measured at mid-span of test beam.

Fig. 12 shows the measured load–deflection curve of the test beam. According to the curve, the test beam shows good ductility. The deformation of the test beam can be divided into four stages based on the deflection and the strains at the mid-span.

The very first stage of deformation is an elastic stage in which the deflection increased almost linearly with the flexural load. Point A in Fig. 12 is defined as the ending point of this stage because at this point the longitudinal normal strain of the bottom of the bottom steel tube reached its proportional limit strain (1042 $\mu\epsilon$). The deflection of the test beam at this stage was small, which is only 1/450 of the span length.

The stage following the elastic stage is regarded as an elasto-plastic stage where the bottom steel tubes started to yield by tension and the load–deflection curve became nonlinear. At the ending point of this stage, Point B in Fig. 12, the longitudinal normal strain of the top of the

bottom steel tube achieved the yielding strain ($1558 \mu\epsilon$). The deflection of the test beam at Point B is $1/300$ of the span length.

At this stage, the deflection increased rapidly with the flexural load. Cracks started to occur at the bottom of the top concrete slab when the test load was 270 kN, indicating that the neutral axis of the cross-section has shifted to within the top concrete slab. When the test load reached 385 kN, the cracks extended upward from the bottom of the concrete slab to a height of $1/3$ of the slab thickness. Deformations of the test beam at this moment were visibly perceptible to the researchers. The deflection at the mid-span was 199.7 mm ($1/46$ of the
