Precast Concrete Pavements and Results of Accelerated Traffic Load Test

ABSTRACT

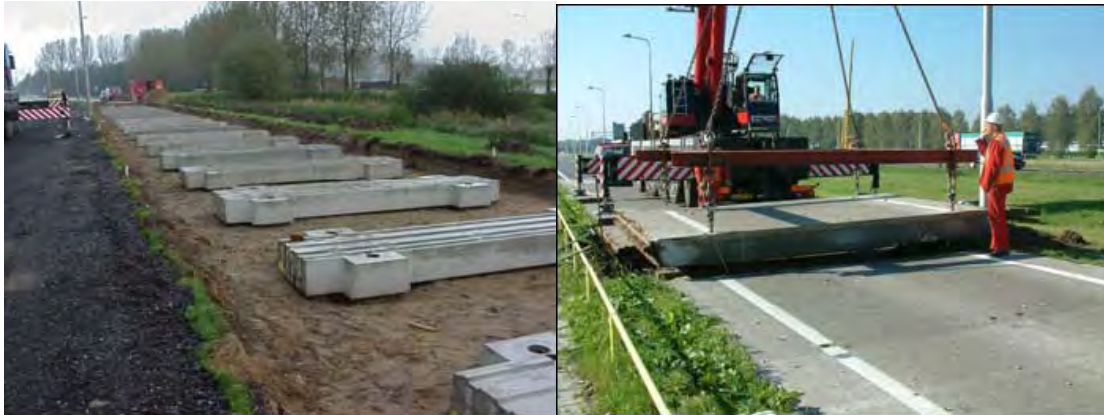
Figure 1. The ModieSlab test section along motorway A50.

top layer to reduce traffic noise, tube-banks for temperature-control, and space to install instrumentation such as weighing modules or vehicles counters. A pilot section was constructed on a foundation of piles in the access to a rest area on the A50 motorway in the Netherlands (Figure 1). Very good performance was observed after 1.5 years in place (6). There were some unexpected problems with smoothness, which necessitated changes in the production process, and there were problems with raveling (surface deterioration due to aggregate loss) and polishing of the porous concrete wearing course (7). Another 100-m section was built in the summer of 2006 spanning two lanes and the shoulder on the A12 motorway, which reported considerable reduction on tire-pavement noise levels (8).

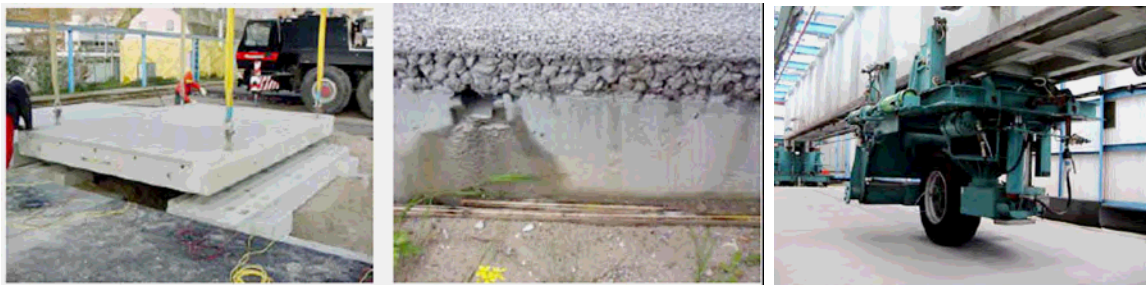
Figure 2. Construction of the ModieSlab test section for accelerated pavement testing and the LinTrack facility (9).

Structural evaluation of the ModieSlab concept took place at an accelerated pavement testing facility located in Delft, called the LinTrack (Figure 2). A set of four precast slabs were installed and loaded with 250,000 wheel repetitions in the main wheelpath and 10,000 in the slab's edge at a load level of 75 kN (16,860 lbf). A thinner slab replaced one of the original panels, and 130,000 more repetitions were applied to further investigate structural capacity. Accelerated load test results, combined with finite element modeling, indicated that the ModieSlab concept would be "free of any fatigue deterioration by traffic." Details on the accelerated testing of the ModieSlab are available elsewhere (7, 9, 10). More research is being conducted in the Netherlands regarding the use of precast pavements for bridges and roundabouts (Figure 3).

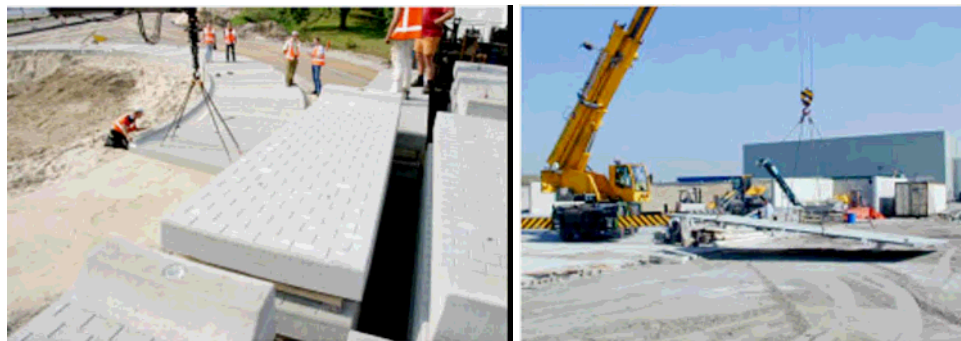
Figure 3. Precast concrete elements in a roundabout and panel lifting test in the Netherlands (12).

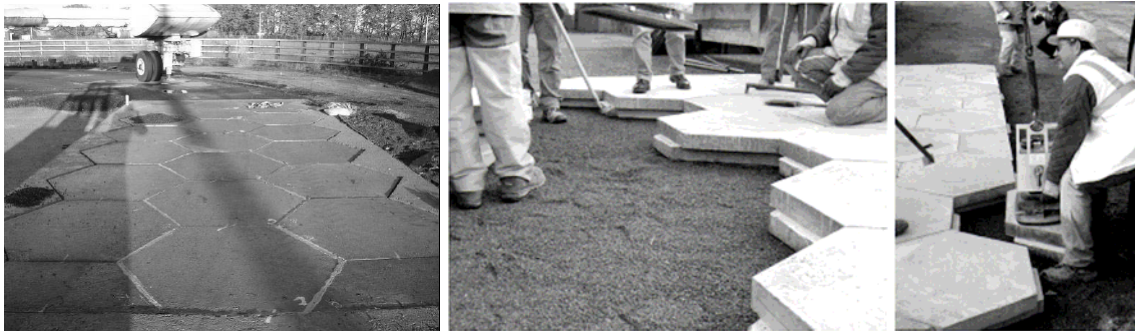
Figure 4. Accelerated pavement testing of hexagonal slabs and installation of keyed slabs in France (13).

In France, in the pursuit for “removable urban pavements,” researchers at the Pont et Chaussées laboratories (LCPC) (13) are evaluating the option of precast concrete slabs. A hexagonal shape, as opposed to a more typical rectangular shape, is being evaluated. As part of the concept, the slabs have to be mechanically independent in order to be easily lifted during maintenance operations, and therefore only a soft polymeric water-proof joint is cast in the

joints. The slabs are installed over a granular bed. The base course has a structural function, so research continues to find an easy-to-dig material, yet strong enough to resist long-term traffic loadings. The slabs are 200 mm (8 in.) thick and have an equivalent diameter of 1,540 mm (60 in.). Accelerated pavement testing has been carried out successfully at the fatigue-carrousel at LCPC. A second type of slabs was evaluated with smaller panels and keyed joint to provide some level of load transfer (13).

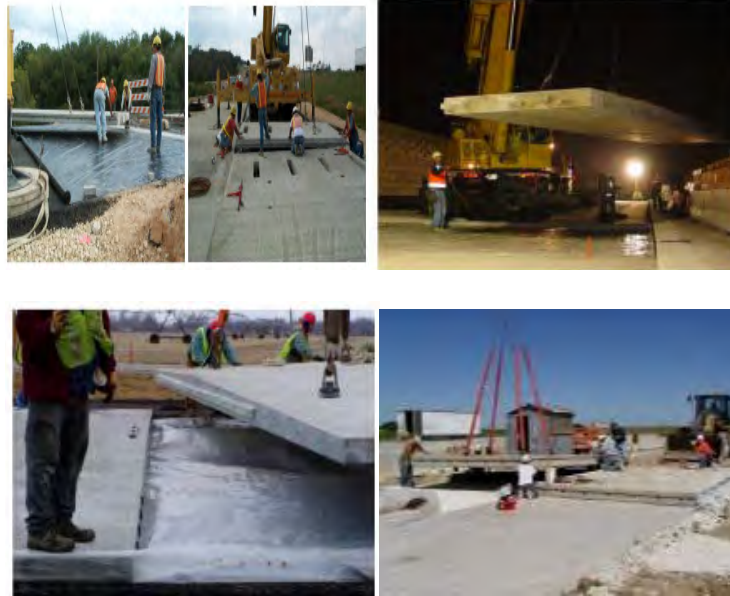
Figure 5. Precast slab projects in Texas, California, Missouri, and Iowa sponsored by the Federal Highway Administration (1).

A more concerted effort has taken place in the last few years to implement the use of precast concrete slabs in roadways in the United States. The Federal Highway Administration (FHWA) has been providing engineering support and funding to State agencies in a series of demonstration projects to advance the use of precast pre-stressed concrete pavement (PPCP) for pavement construction and rehabilitation. To date, projects in the States of Texas, California, Missouri, and Iowa have occurred (Figure 5). Each project has required different design elements, demonstrating the flexibility of the PPCP concept (14, 15).

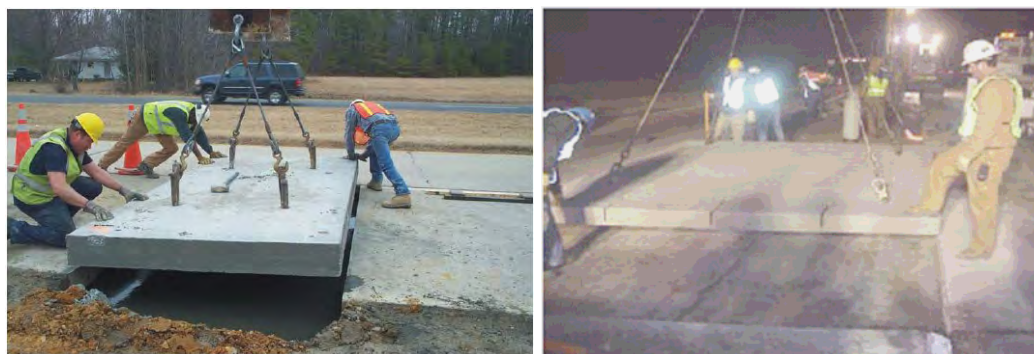
Figure 6. Precast concrete panels for experimental slab replacement in Virginia (17) and in Colorado (18).

Independently from the FHWA efforts, a project in the State of Virginia (17) evaluated the use of precast concrete patches for repairing jointed concrete pavement. Six panels were placed, three with dowels cast into them during fabrication and three with dowels inserted in place (dowel bar retrofit). After 1.5 years there were no distresses on the replaced slabs except for a few hairline cracks; however, there were failures in the joint area, mainly because of dowels, which were attributed to poor construction practices (Figure 6). A project in Colorado was carried out in 2003 where 157 distressed concrete slabs were rehabilitated with precast concrete panels at 18 separate locations. The panel thicknesses ranged from 140 to 184 mm (5.5 to 7.25 in.) and panel lengths varied from 3.7 to 6.1 m (12 to 20 ft). The repair clusters consisted of 2–8 slabs connected by fiberglass ties. High-density polyurethane foam was used to stabilize and slab jack the panels to match elevations. Evaluation a year after construction revealed cracks in approximately 20 percent of the precast panels, with the majority of these cracks in the vicinity of the fiberglass stitches. Probable causes include nonuniform support in the vicinity of the stitches resulting in tensile stresses at the top fibers of the panel; longer effective slab lengths due to joint ties; and inadequate slab thickness to carry the axle loads (18).

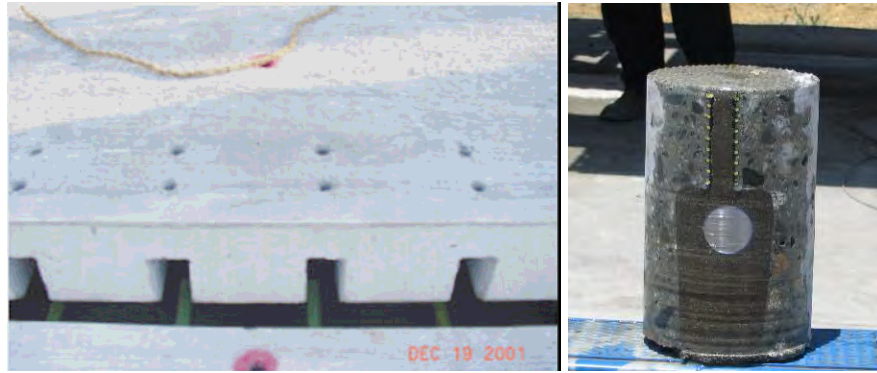
Figure 7. Doweled joint and core showing dovetail slot/dowel bar connection.

Standard load transfer dowels are cast at one end of each slab at locations that match the location of dovetail-shaped slots cast in the bottom of each adjacent slab as seen in Figure 7. Similarly, standard tie bars (or the female half of a standard tie bar) are cast at one side of each slab matching the location of slots cast in the adjacent slab. Figure 7 is a closeup view of how dowels and slots align during the placement process.

Two grout ports are cast in the slab over the top each slot to make it accessible for grouting after the slab has been placed. Grout is pumped into one port until it exudes from the other, completing the structural load transfer connection from slab to slab. Fully grouted slabs are essentially the equivalent of cast-in-place pavement slabs and perform the same way. Dowel slots cast on the bottom of the slabs provide two benefits. First, they keep dowel grout on the bottom, protecting it from deicing chemicals and degradation from freeze–thaw activity. Secondly, they keep dowel grout out of sight, maintaining a uniform-looking, high-performance pavement surface. Figure 7 shows a core taken from a dovetail slot/dowel bar connection.

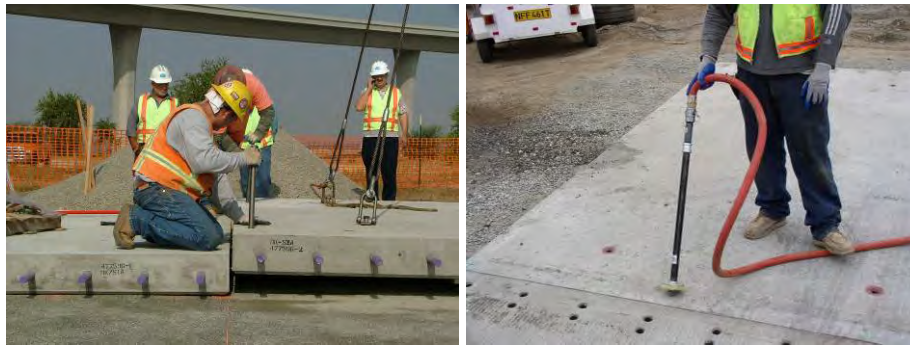
Figure 10. Precise placement of the slab on the sand bedding layer and hose with fitting for injecting grout.

- A 100-mm (4-in.) cement-treated base (CTB) course placed upon the original ground at the test site.
- A thin (8 mm [0.315 in.]) layer of fine bedding material (stone sand).
- Precast Super-Slabs™, 225 mm (9 in.) thick, placed upon the precisely graded subbase and grouted as described in the foregoing (shown in Figure 10).
- Diamond grinding of the top surface of the slab to meet smoothness requirements of the project.

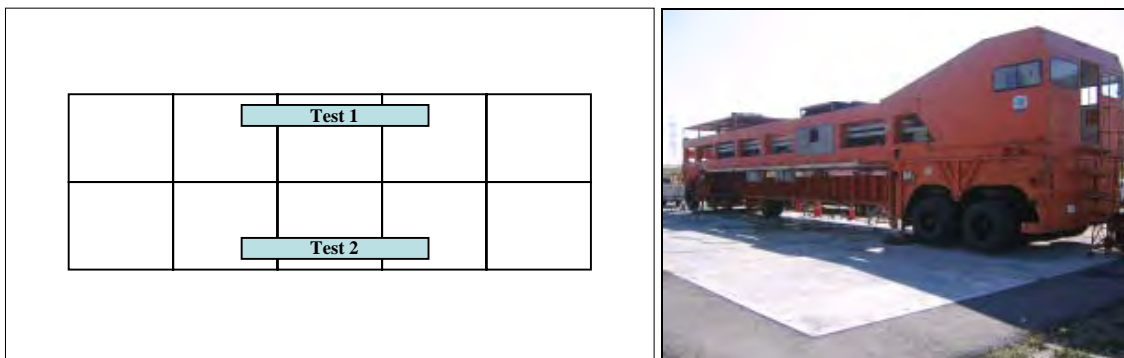
Figure 11. Test sections layout and HVS during load testing.

Two test sections were evaluated between June 2005 and August 2006 using a heavy-vehicle simulator (HVS), shown in Figure 11. The UC Pavement Research Center operates two of these machines, and they have been used extensively since 1995 to evaluate various paving technologies. The evaluation of the Super-Slab™ system had three main test objectives:

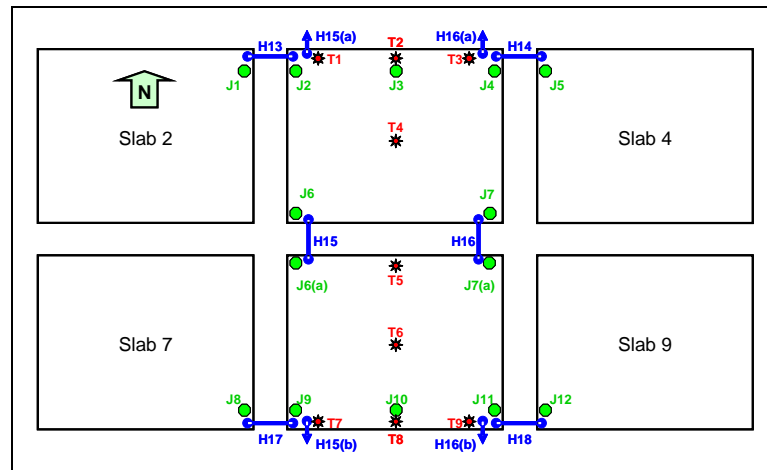
Figure 12. Location of displacement instrumentation and thermocouples.

The instrumentation of the test sections (see Figure 12) consisted of displacement sensors mounted vertically near the two trafficked joints and at mid-panel on each section. Horizontal displacement sensors measured joint opening, and multidepth deflectometers recorded vertical deformation at the various layers of the system directly in the trafficked area. Thermocouple stacks were used to register temperature through the depth of the slabs.

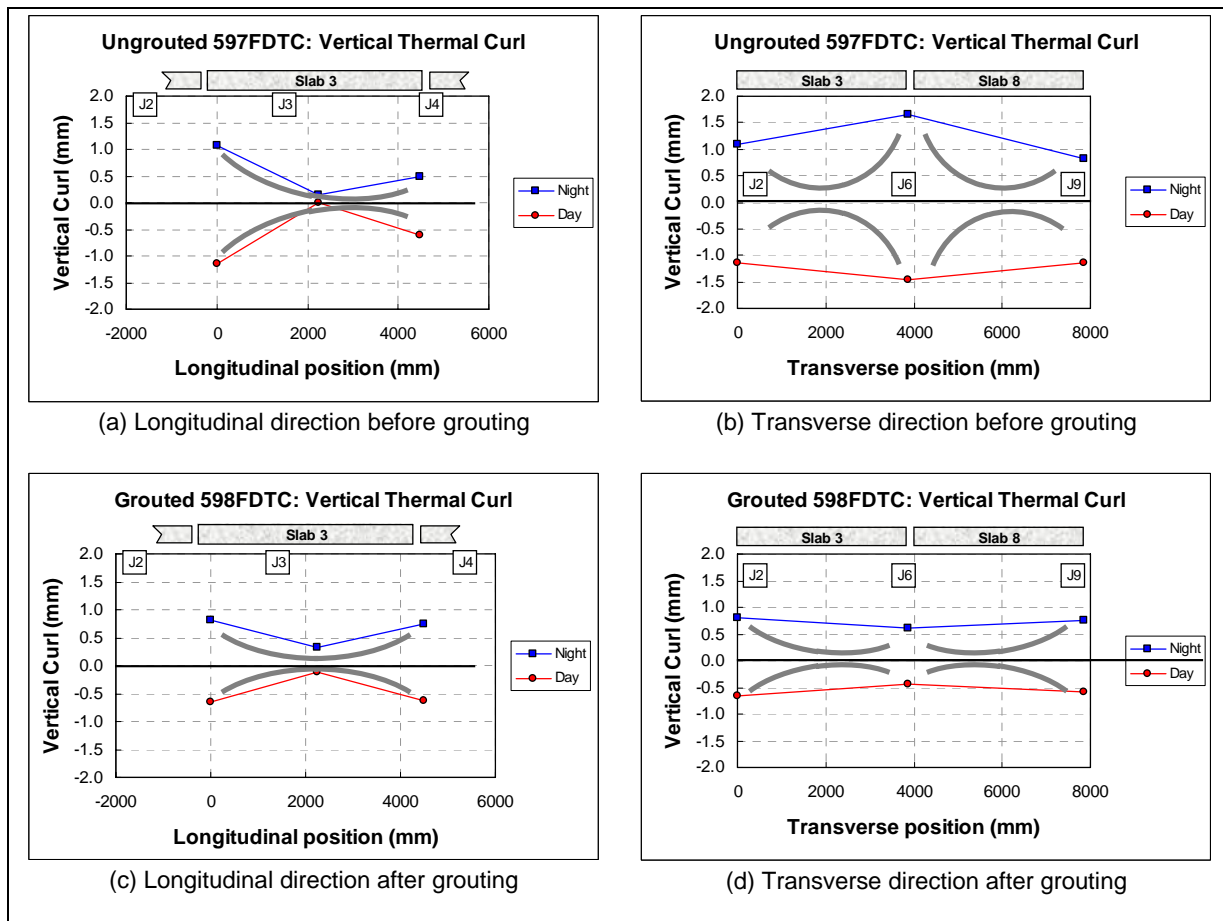
Figure 13. Comparison of the vertical deformations caused by thermal curl of the slabs before and after grouting, in the transverse and longitudinal directions.

The thermal deformations (with no traffic loads) were compared before and after grouting. The vertical displacement at an interior corner reduced by grouting from ± 1.5 to ± 0.5 mm (± 0.059 to ± 0.020 in.) as shown in Figure 13. In the un-grouted condition each slab curled separately, while after grouting the presence of tie bars and grout in the joint (coming from the tie-bar grout slots), restrained the movement, reducing self-weight stresses and ensuring better support conditions. Along the longitudinal direction, on the exterior corners (on what would be adjacent to the shoulder), the effect of grouting was minimal (see Figure 13).

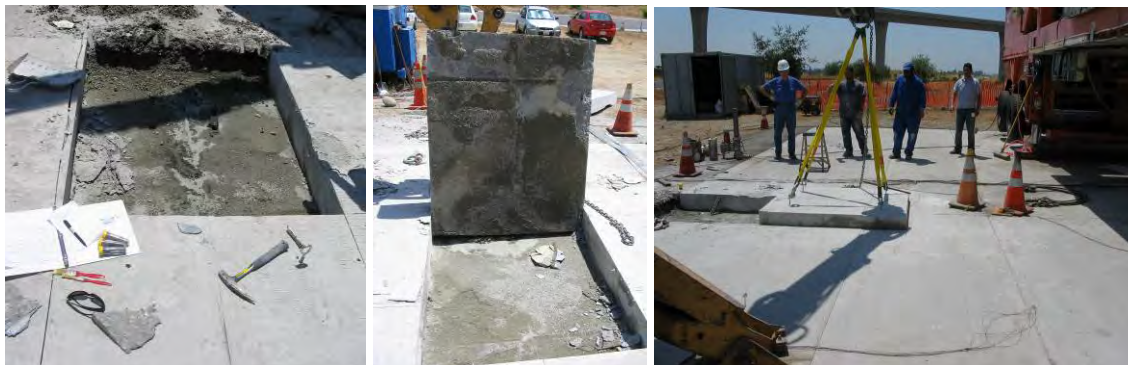
Figure 14. Investigation of void under the slab in section 2.

No distresses were observable at this stage either, despite the fact that considerable pumping of material from under the slab occurred during the wet trafficking. The pumping of fine sand, however, did not result in any significant rise in corner deflections. An investigation was carried out to evaluate the extent of the suspected voids under the slab caused by pumping. It revealed that the pumped material was comprised of the finer particles from the sand bedding layer and disintegrated bedding grout. There was no clearly noticeable void in the wheelpath under the joint, but there were rather widespread marks of washed fines.

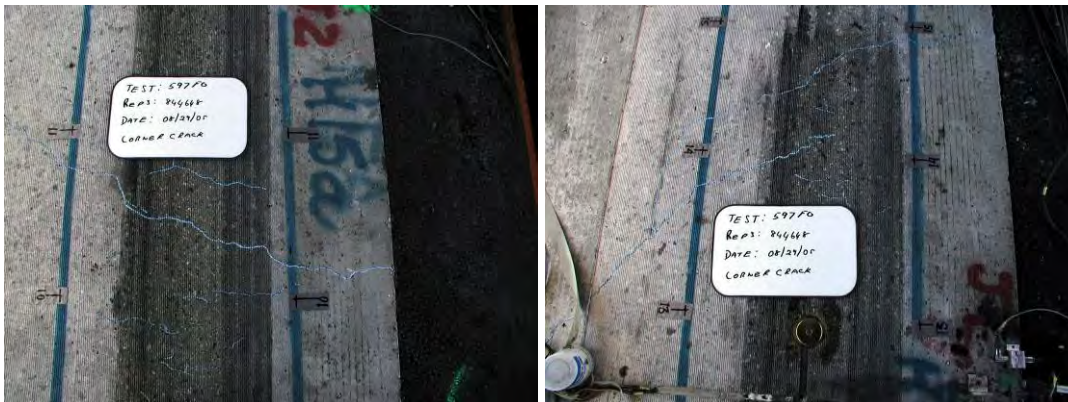
Figure 15. Fully developed corner cracks at one of the transverse joints of section 1, when loaded in dry pavement conditions

Corner cracks appeared next to one of the two loaded joints in section 1. These structural corner cracks, on both sides of the joint, were first observed at 0.762 million load repetitions and were fully developed at 0.845 million load repetitions. HVS trafficking in dry conditions was stopped when, after the cracks had appeared, the pavement responses were once again stable. After the wet traffic was initiated, the slabs were able to withstand 79 million ESALs before traffic had to be stopped, a clear indication of a still sound structural condition of the cracked slabs.

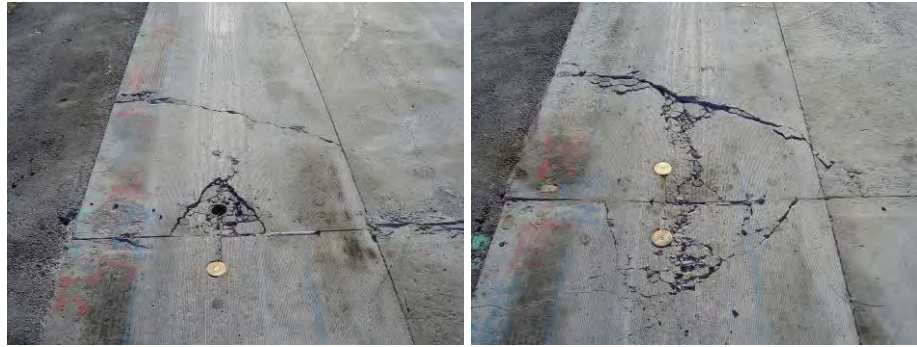
Figure 16. End of life at the two joints of section 1, loaded to failure.

Failure of the section was reached in the form of a localized collapse in one of the joints and a more extended corner crack on the other joint. Forensic investigation revealed that the localized failure happened between dowel bars, exactly where the channelized traffic loaded the pavement. Even though the failure happened at the location of one of the multi-depth deflectometer sensors, it was concluded that this had no effect. The combined observations point toward concrete fatigue under channelized traffic and the loss of support caused by pumping. The other joint presented a failure that can be considered typical of cast-in-place, with large concrete cracks. Both failed joints are shown in Figure 16 (as size reference, the brass sensors' caps are 75 mm [2.95 in.] in diameter) (21).
