Assessment and restoration of the first Greek power plant – Registered monument of industrial heritage

C. Maraveas*, K. Tasiouli

C. MARAVEAS PARTNERSHIP – Consulting Engineers, Athens, Greece

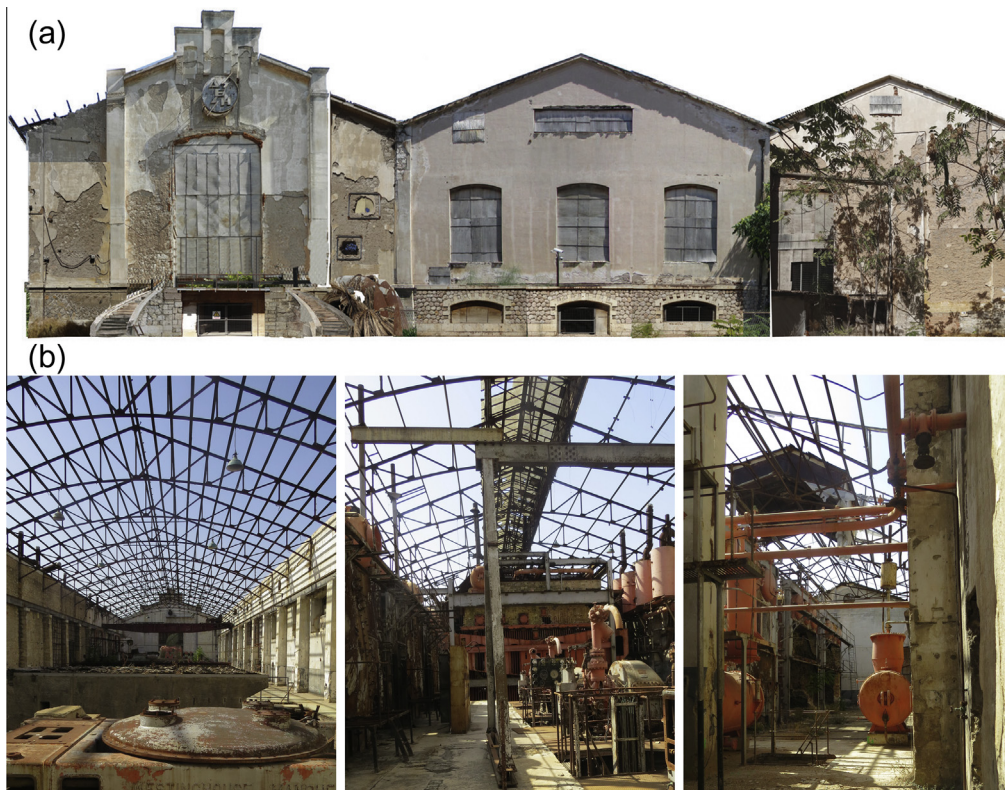
Fig. 1. Exterior (a) and (b) Interior of buildings A, B and C2 on the mezzanine level.

The building was constructed in 1902 and some modifications to the initial structural system were made during the 1930s and 1950s in four basic construction stages. During the first decade of 2000 the roof sheeting was removed as part of the nationwide project of eliminating all existing asbestos in old buildings, which lead to significant degradation of material mechanical properties (Fig. 1).

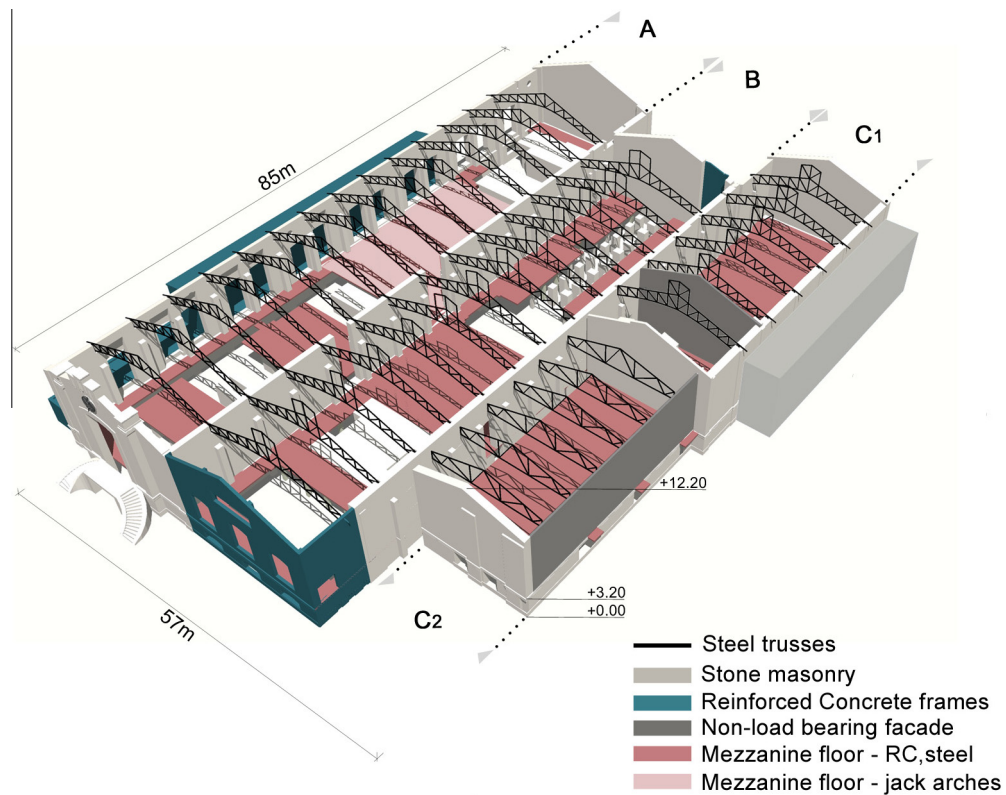
Fig. 2. 3D Illustration of the structural layout of the existing building.

The building consists of three longitudinal parts (A, B, C) (Fig. 2). The total plan has a rectangular layout with approximate dimensions of 85 m by 3 parts of 19 m, the roof level is 12 m above ground level and the mezzanine floor (which supports the machinery) is 3 m above ground level. Building A has an internal length of 84.40 m and width of 19.45 m. Building B is smaller, with internal dimensions 77.00 m × 19.50 m. Building C is comprised of two parts and was constructed in two stages during the 1930s, part C1 with internal dimensions 29.30 m × 15.64 m and part C2 with internal dimensions 41.80 m × 14.00 m. The perimeter load bearing masonry walls have a variable thickness and include local thickness strengthening buttresses at the axes of the existing roof trusses, every 5.30 m approximately. The thickness of the walls varies from 0.80 m at the top to 1.30 m at the base and the thickness of the buttresses is about 0.60 m. At building B parts of the walls have been demolished and replaced with reinforced concrete frames and brick masonry infill.

The roof consists of steel trusses with fastened double-angles. The trusses have a variable height (1.30 m at the edges and 2.55 m at the middle), with the lower flange arc shaped, and are supported on the walls. In building C2 (Fig. 2) only, the longitudinal facade is not load bearing and a steel frame is supporting the steel roof trusses whose lower flange is not curved. The mezzanine floor of this part is structurally independent from the masonry. The existing configuration of the structure, which is based on the technological expertise of its time, is safe for bearing vertical loads but not seismic loads, as specified by current regulations. The new use of the building as a museum also increases the demands for structural system strength and serviceability.

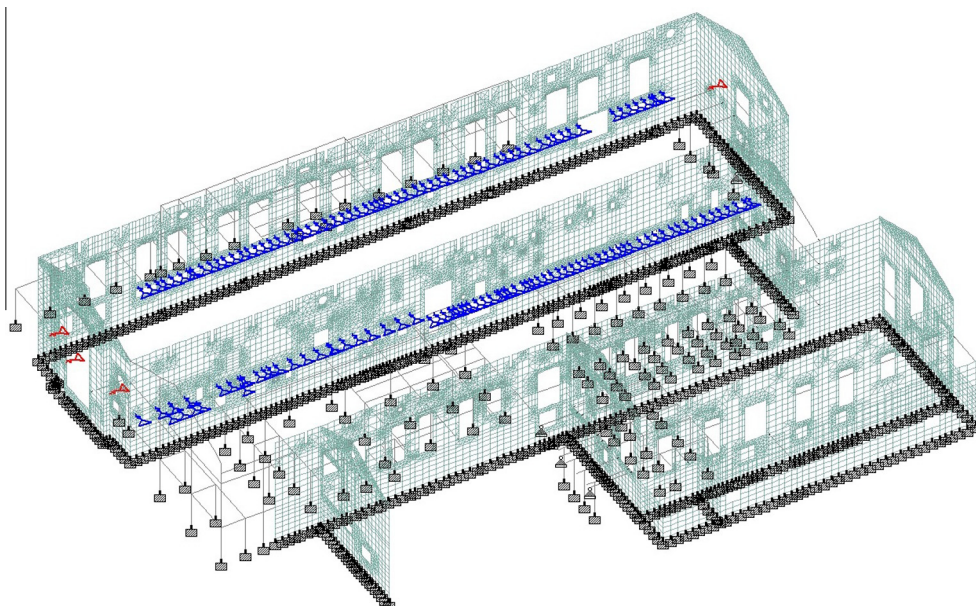
Fig. 3. 3D finite element model of the existing structure.

STAAD.Pro V8i [5] software by BENTLEY was used for the analysis of the structure. A model was created which includes the main shell of the buildings and various additions and neighboring structures but no roof structures as at this stage they do not provide diaphragm, due to their negligible stiffness caused by lack of lateral support, and only transfer vertical loads. The assessment of the structural capacity of the existing steel roof trusses was achieved through separate models and only for loads arising from static forces and not seismic.

The load bearing masonry walls were simulated with finite surface elements (plate elements), which include both membrane and bending function and are ideal for linear elastic shell analysis. The finite element meshing was implemented in such a way as to take into account recesses, openings, differences in thickness etc, in order to realistically simulate the structure geometry. The basement and mezzanine concrete structures and certain neighboring buildings attached to the main shell, which are included in the model because they structurally affect the walls, were simulated with the use of beam or plate elements and their diaphragmatic function was taken into account by imposing common displacements at the nodes of each diaphragm. The basement and mezzanine steel structures do not ensure diaphragmatic function, but their influence is taken into account at the model, since apart from load transferring they also have a kinematic dependence with the shell, by affecting the lateral direction of the walls (Fig. 3). Separate analyses were conducted for all those mezzanine structures that could not ensure diaphragmatic function (steel frames) in order to estimate their horizontal stiffness by calculating the corresponding displacement caused by a horizontal load. Equivalent linear elastic springs with axial stiffness equal to the horizontal stiffness of each frame were then used in the main model in order to simulate their kinematic dependence with the masonry. The aforementioned methodology was adopted in order to simplify the model and to reduce the calculation time. Following this analysis the steel frames structural assessment was made by imposing the calculated displacements to the separate models. Most of those structures proved to be adequate in resisting forces arising from the imposed displacements due to their low stiffness. Direct stiffness method was used to obtain the internal forces. The stiffness of the wall elements was taken as that of the full section for static load cases and as that of the half section for seismic load cases according to EN1998-1 [13].

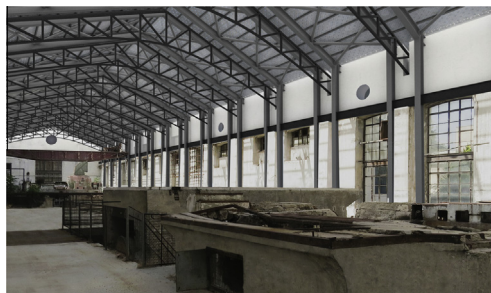
Fig. 4. Render of the new pairs of steel frames aligned symmetrically with the existing steel truss girders in building A.

Based on the aforementioned factors, 15 pairs of new steel rigid frames and horizontal X-shaped bracing at the roof were proposed for the structural rehabilitation of the overall stability of the walls and roof in buildings A and B (Fig. 4). The new frames were aligned symmetrically on both sides of the existing girders and their sections were chosen as standard H-shaped so that architecturally the intervention is as discreet as possible. The top flange of the girders was placed higher than the top chord of the existing truss girders in order to provide enough space for the inclusion of the horizontal bracing and so that the roof loads are transferred only to the new girders. The new steel columns are connected to the masonry walls with anchor bolts every 1 m approximately along the height in order to ensure kinematic constraint and cooperation with the walls. The role of these connections is primarily to facilitate the transfer of forces from walls to the new roof diaphragm and secondarily to support the walls and enhance their performance in out plane bending (Fig. 8). In building C the roof is completely reconstructed with trusses following the original geometry and new horizontal X-shaped bracing.

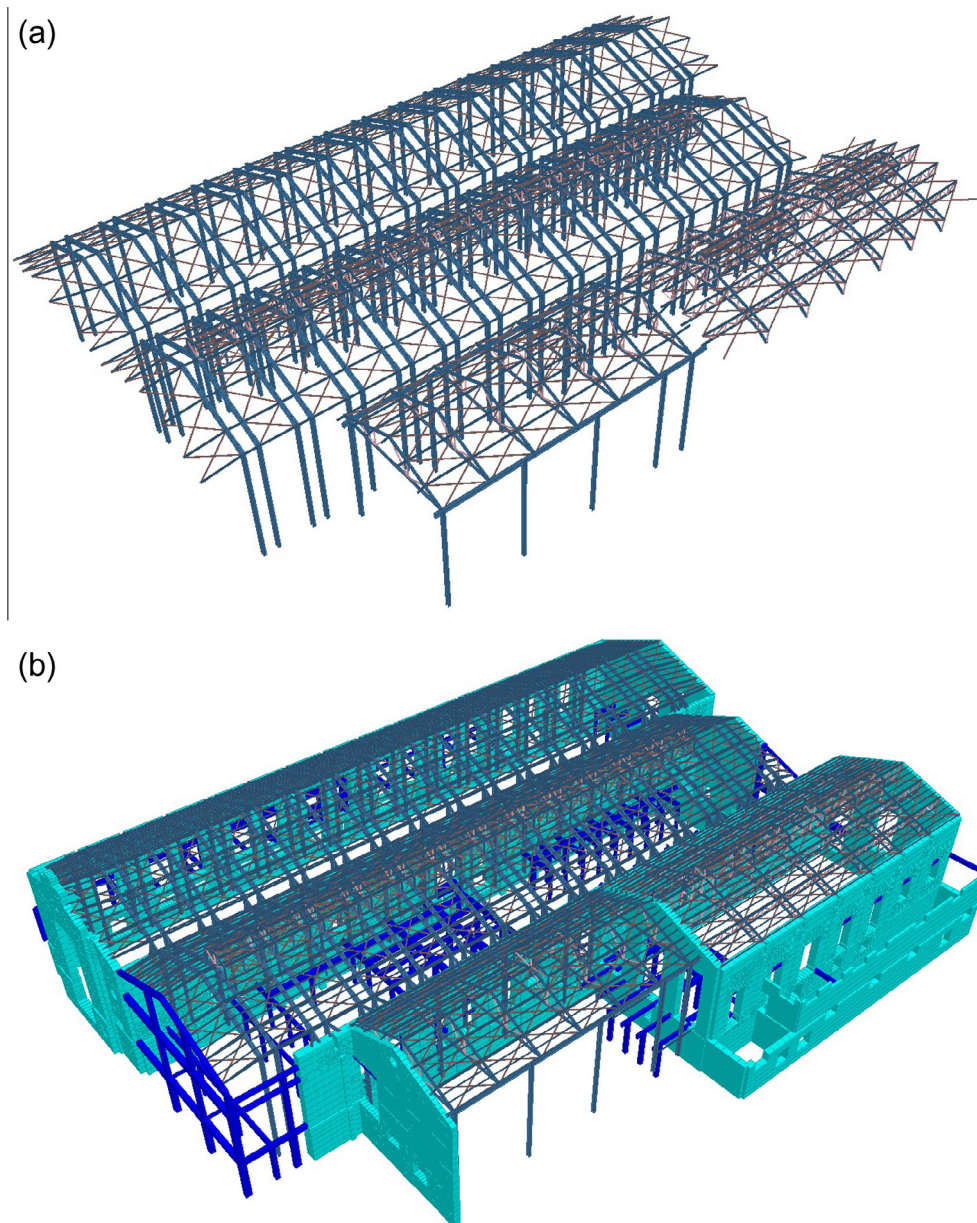
Fig. 5. Simulation of the structure (a) Structural layout of new steel structures (b) 3D model of the structure with the interventions.

A new analysis was then conducted again using STAAD.Pro V8i [5] software by BENTLEY. For this analysis a complete model was created by adding the steel roof structures to the original model (Fig. 5). The steel roof structures were simulated with linear members (beam elements). The secondary members of the trusses were specified as truss members (only taking axial force), while the horizontal and vertical bracings were specified as tension only members (only taking tensile force). Purlin members were included in the model. The existence and contribution of the preserved old roof trusses was ignored. The all important structural cooperation of the walls with the roof steel structures, which in reality is achieved by connecting them along the height using anchor bolts at regular intervals, is simulated by using pairs of truss members of appropriate stiffness connecting the steel column nodes to the nodes of wall elements.

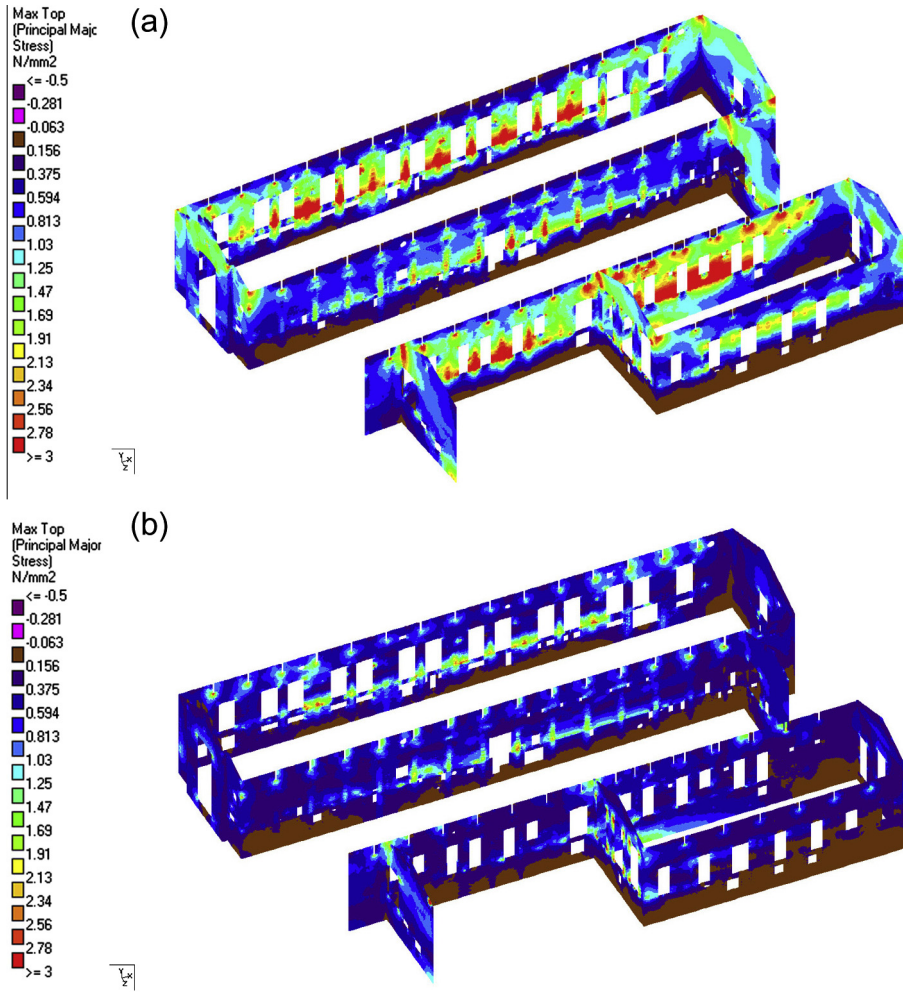
Fig. 6. Maximum principal (major) stresses (a) Existing (b) After the interventions. Favorable areas indicate tensile stresses lower than 0.1 MPa.

With the implementation of the structural interventions described above, the roof diaphragm was retrofitted and an approximate 40% reduction was achieved in the out of plane moments at the base of the walls (Table 2, Fig. 6). However,

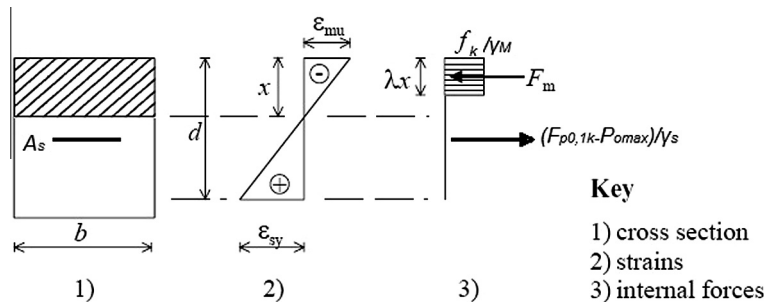
Fig. 7. Strain–stress distribution and internal forces at failure of prestressed masonry.

According to EN1996-1-1 [12], the design of prestressed / reinforced masonry members should be based upon the assumptions that the stress distribution over the compressive zone is uniform and does not exceed f_k/γ_M , the limiting compressive strength of masonry is $\varepsilon_{mu} = -0.0035$, the tensile strength of masonry is ignored and the tensile strain of the reinforcement ε_s is limited to 0.01 (Fig. 7).

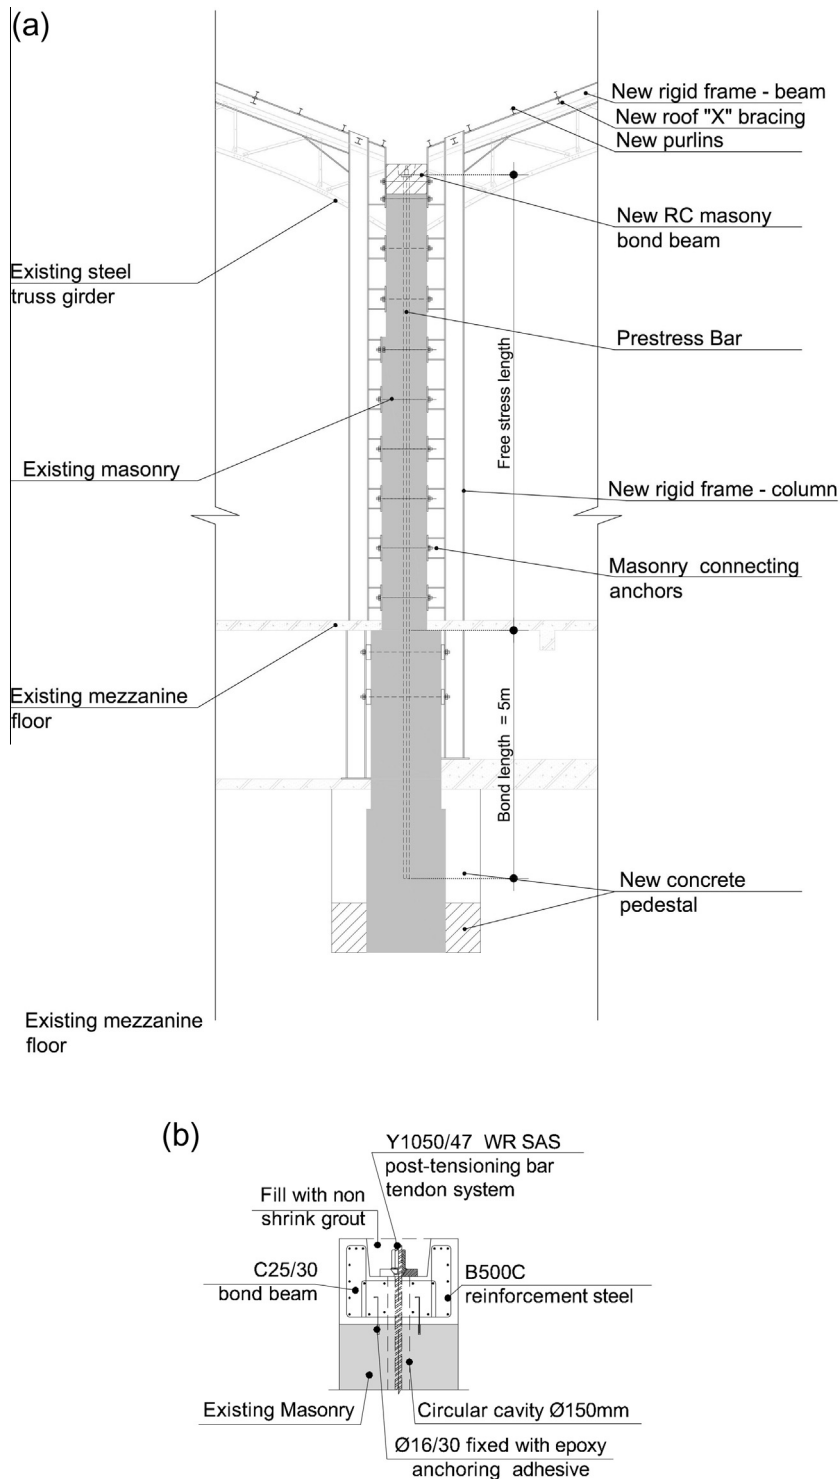
Fig. 8. (a) General layout of structural interventions (b) Structural detail of post-tensioned masonry on the top of the wall (live end).

stability because the bond strength between the strips and masonry cannot be exactly estimated. Moreover, the outer facade of the building must remain uncoated on the base level, something which poses another restriction to the anchorage of CFRPs. Thus the solution proposed is to apply vertical post-tension to the masonry walls according to the following scheme (Fig. 8): Circular cavities of 150 mm diameter are drilled from the top of the masonry by center core drilling every 2 m approximately. An in situ concrete perimeter bond beam is then constructed with circular cavities. An SAS post-tensioning bar system $\varnothing 47$ is inserted from the top of the wall into every cavity, then stressed at the live end which is placed on the perimeter bond beam at the top of the walls and finally grouted over. Before the application of prestress, cement injections for homogenizing the masonry are applied.

A major challenge for the design was the anchorage of prestress bars during post tensioning, as they are inserted into the non accessible core of drilled circular cavities. Thus a procedure akin to rock anchoring was adopted by grouting the fixed/bond length before stressing. The required length was calculated according to EN1996-1-1 [12] for confined concrete infill stronger than C25/30 as long as the cavity is at least 150 mm in diameter and the grouting is specified as equivalent of C30.
